## **1.0 ANALYSIS OF BROWNFIELDS CLEANUP ALTERNATIVES**

### **1.1 Introduction/Background: Site Location and Purpose of Analysis of Brownfields Cleanup Alternatives**

**FIGURE 1 - SITE LOCATION MAP**  
**GETCHELL ICE**  
**1 Union Street**  
**Brewer, Maine 04412**

**FIGURE 2: SITE FEATURES**  
**GETCHELL ICE, 1 AND 11 UNION ST, BREWER, MAINE**  
Project No.: BE-683

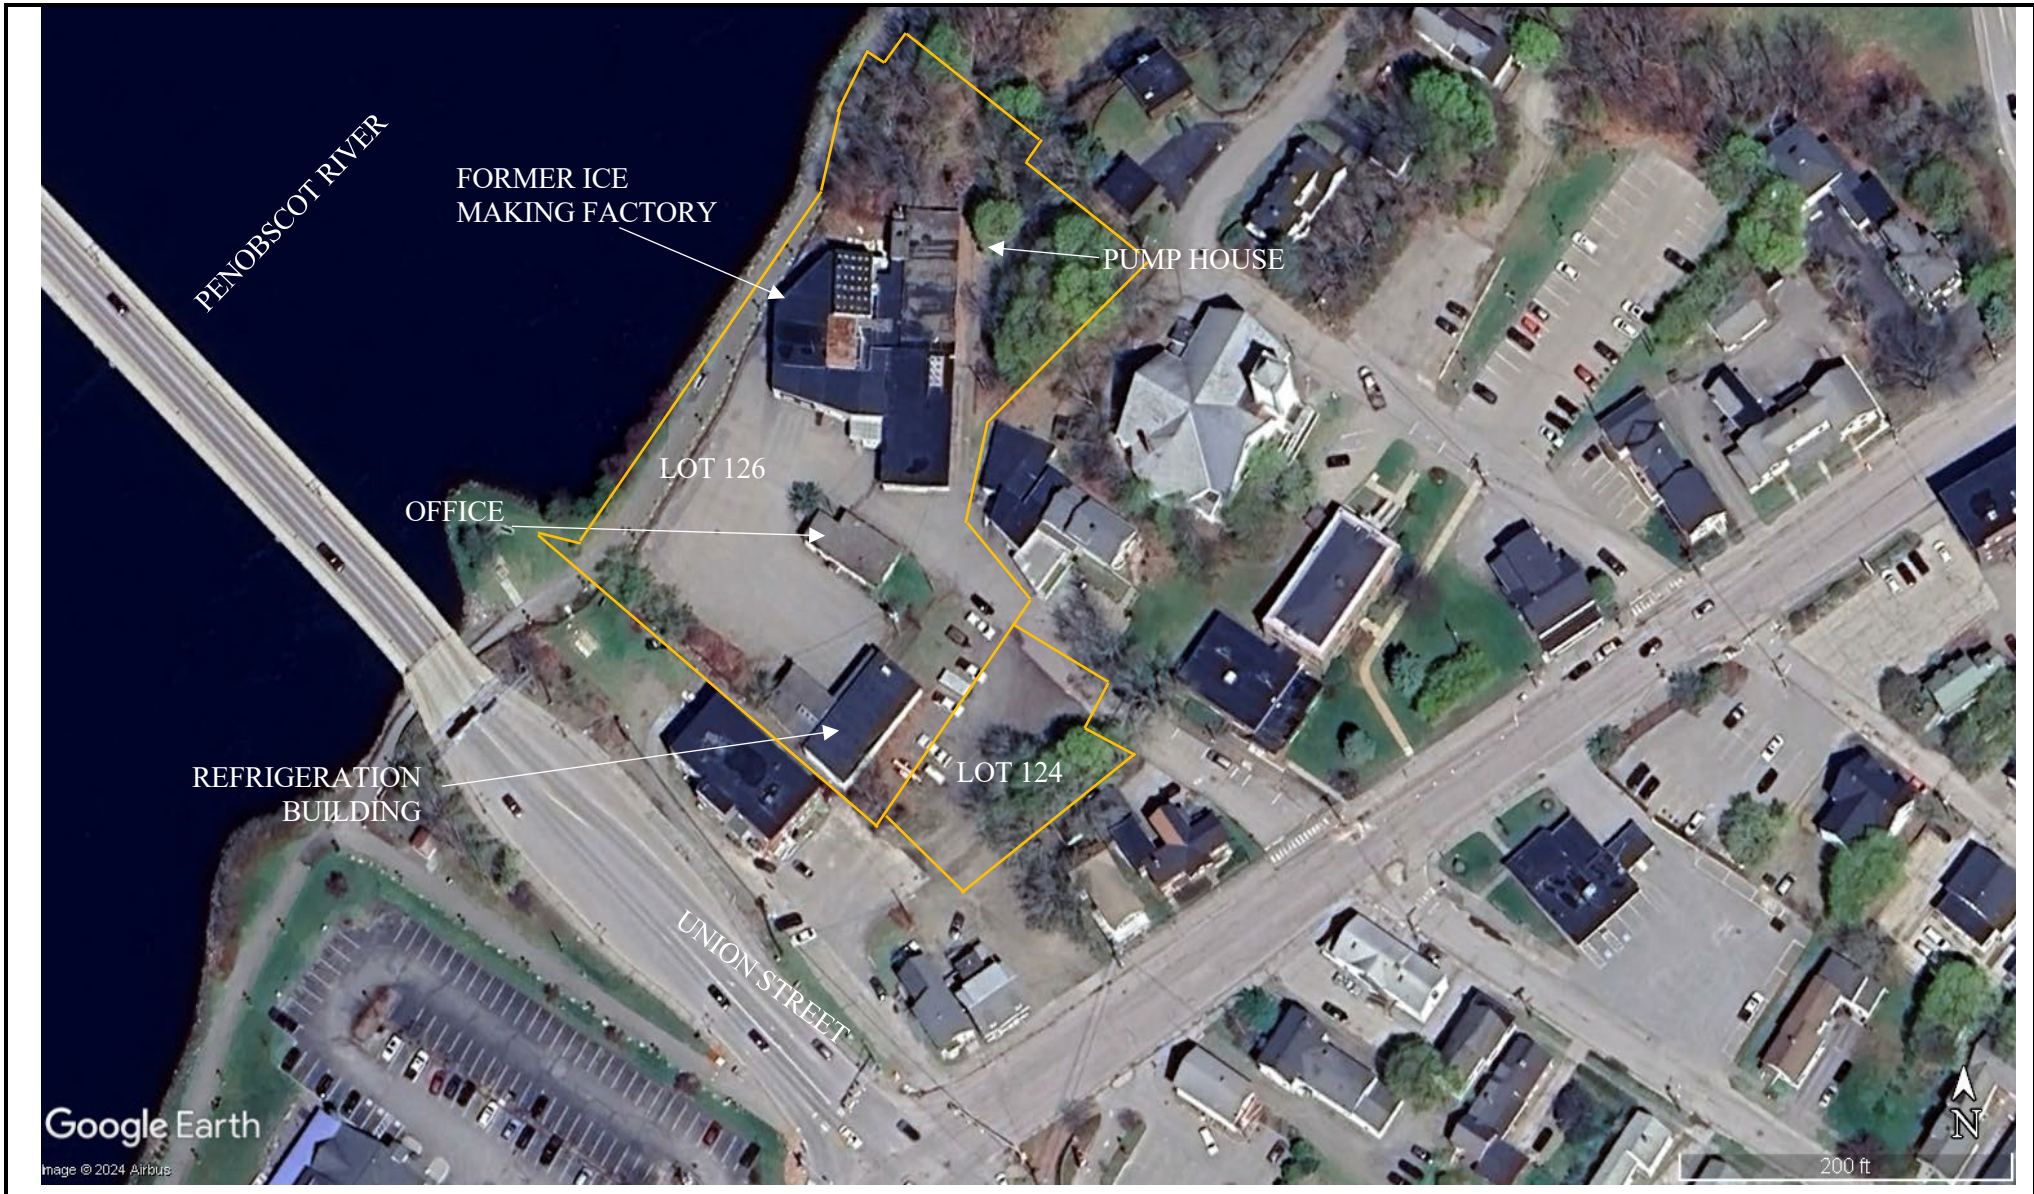
The subject property is an approximately 2.40-acre property developed with a vacant former ice making facility, refrigerated building, and office building and is located at 1 & 11 Union Street in the City of Brewer, Maine. See Figure 1 for a Site Location Map. Information obtained from the City of Brewer Assessor's Department indicated that the tax assessment parcel numbers for the subject property are Tax Map 29 Lots 124 and 126. See Figure 2 for site features.

- Ice Plant Building - Located on the northern portion of the property, this is an approximately 13,027 square foot wooden and metal framed building formerly used to manufacture ice for sale. A 120 square foot loading platform is located on the southern side of the building. The majority of the building is one level with some small structures built onto the top and sides of the original structure.

- Office Building - Located in the center of the property, this structure was originally constructed in the 1950s and it is approximately 2,610 square feet in size with a 25 square foot wooden porch on the northern side of the building. The second floor of the building is used as offices for Getchell Brothers. The basement level has one office, a conference room, bathroom, and the utility room which includes the natural gas boiler and storage of records. The tax card indicated that this structure was built in 1888 but Sanborn maps indicate that it was built between 1950 and 1955.

- Refrigeration Building - Located on the Southern portion of the property, this structure was originally constructed in 1982 and is an approximately 2,554 square foot refrigerated building which was used for storage of ice cream and novelty frozen items. An approximately 961 square foot metal garage is connected to the northern portion of the building and used for storage of equipment and materials. This garage also includes an office area on a mezzanine level.

- Former Pumphouse - Located on the northeastern corner of the property this is a small wooden shed which at one time was used to pump water from the river to the Ice Plant Building. The roof has collapsed on the back side of this structure making it inaccessible.
